Tube well with hand pump

Virtual Sanitary Inspection

WASH FIT Technical module on WATER
Supplementary material
Time to complete: 30 minutes

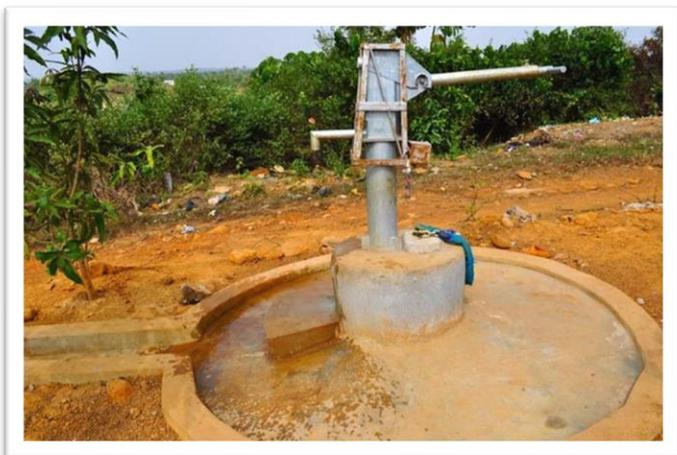
- There is no inspection port (or corresponding cover) in this well type
- There are no sanitation facilities or sanitation infrastructure within 10 meters of the well, although there is a pit latrine 20 meters uphill of the well which serves the facility

- The local soil type is sandy, and is considered to be very permeable
- The well is located on the edge of the facility grounds, away from the facility building

- The perimeter of the facility is not well maintained and there is evidence of animal activity around the well facility (chickens roaming)
- There is an old open tube well located 40 meters uphill from the tube well with hand pump; however, thankfully the facility no longer uses this for, but it is still used by the local community for dumping household effluent (i.e. grey water from washing, bathing, laundry water etc.)

Figure 1. Close-up of the tube well with a hand pump

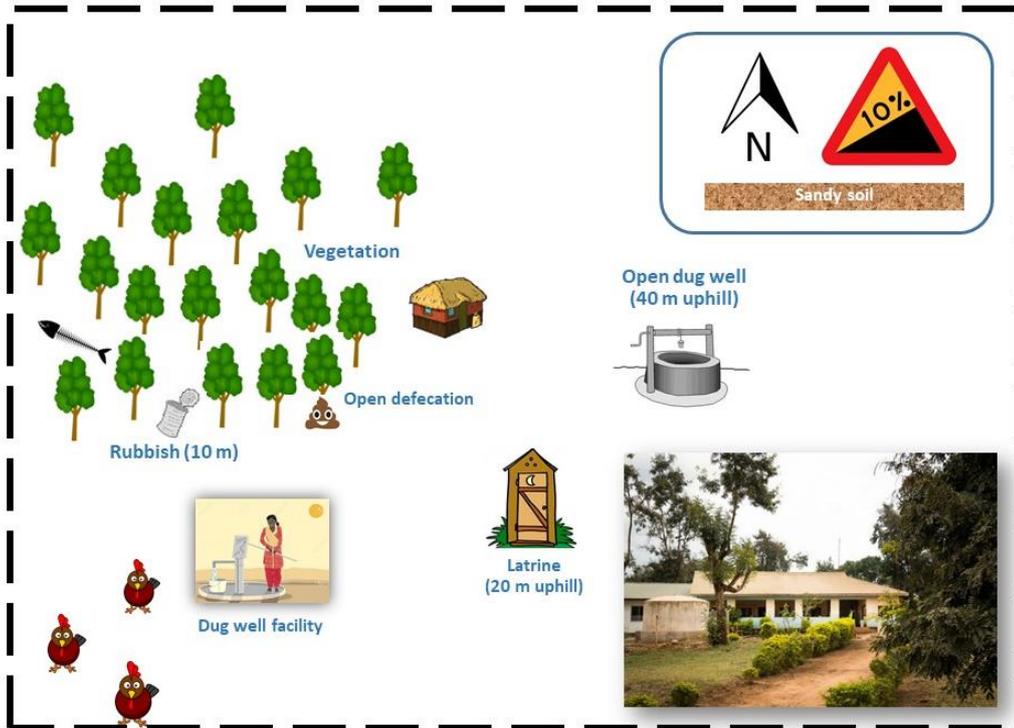
- There is no fence or barrier around the well, although it is adjacent to a heavily vegetated area on the north side of the facility grounds
- This heavily vegetated area is sometimes used to dispose of rubbish from the health care facility, and there are some signs of open defecation by community members

Figure 2. Overview of Waterville PHC (the dotted line is the perimeter of the health care facility)
